# ARC FLASH TESTING

**INFRARED WINDOWS**

**TEST REPORT**

Nº RP LS 12/172

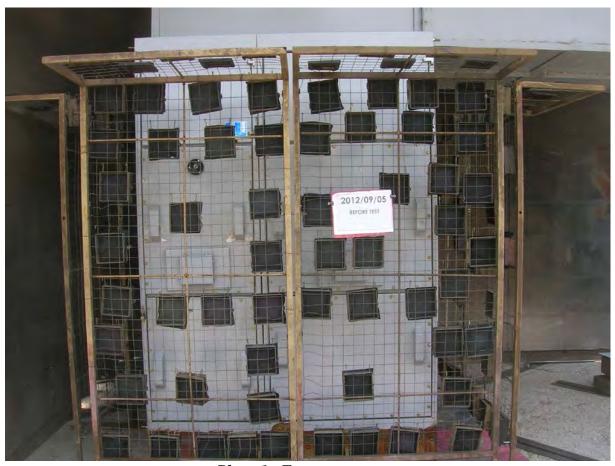
Photo 1 - Test arrangement

The A.C. Metal-Enclosed Switchgears type Maggiore Max under test was prepared and placed under a room simulated by a structure with the ceiling and two walls perpendicular to each other.

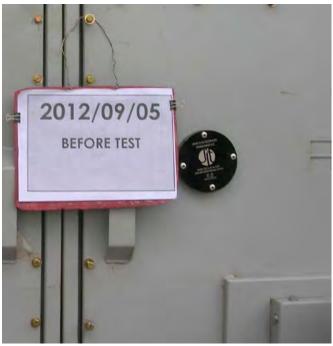
Photo 5 – Before test (InfraPred JIT75)

During the test the InfraPred JIT75 thermographic investigation window was mounted. The window was not damaged, as can be seen in Photo 5, 9.

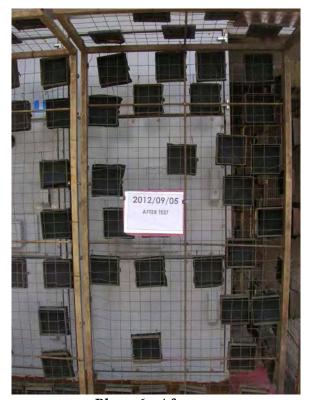
Photo 6 - After test

The indicators for observing the thermal effects of gases were arranged as indicated in Figure 1, according with CEI EN 62271-200: 2005 to verify the type AFLR accessibility on Front, Lateral and Rear sides (see also Photos 3-4, 6-7).

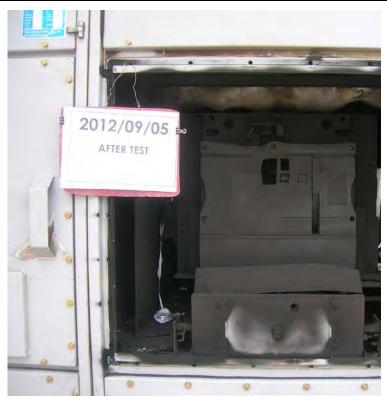
Photo 8 - After test

The conditions of the circuit breaker box after the test are visible in Photo 8.
