Thermography in Transformer and Motor Connection Boxes in Compliance with NR10 and NBR15572 Standards – Rev.4

This article exclusively addresses safety issues related to thermographic inspection of electrical connections of motors / generators and transformers, as well as oil leaks from bushings and the difficulties in carrying out such inspections.

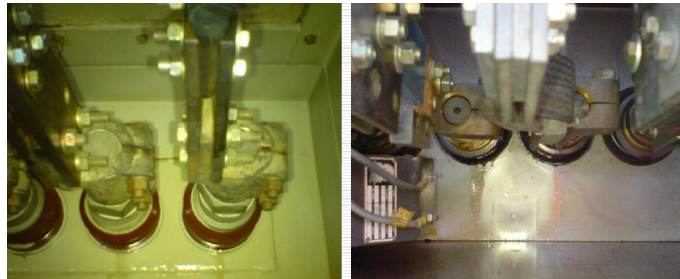
Examples of leaks in transformer bushings – inspection possible through windows with polycarbonate lids and glass lens (Images from JIT Brasil file).

The photos in the sequence show examples of oil leaks in bushings of two transformers, identified in the same inspection, in the same customer.

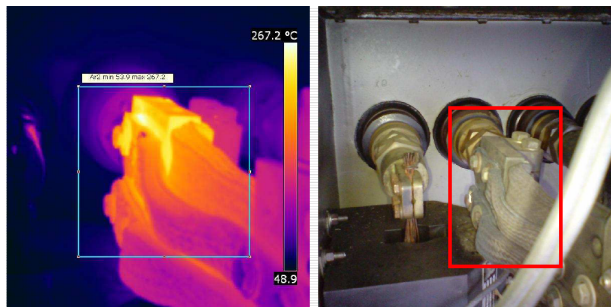
Example of thermogram of electrical connections of a transformer (archive images from JIT Brazil).

The figures below show thermograms of defects identified in oil-filled transformer connections.

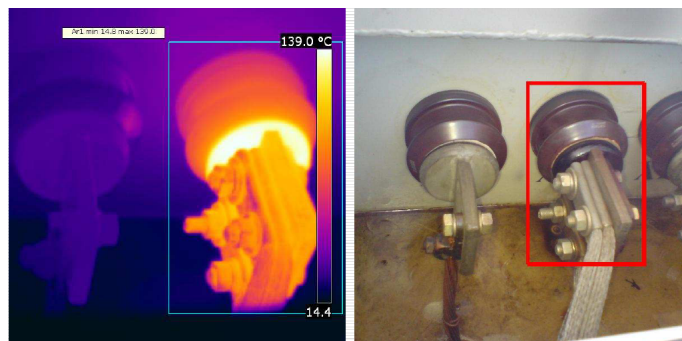
Example of a thermogram of the electrical connections of a transformer with poor electrical contact in the internal connections and the photograph reveals a problem with a leak in the bushing that was overheating (archive images from JIT Brasil).

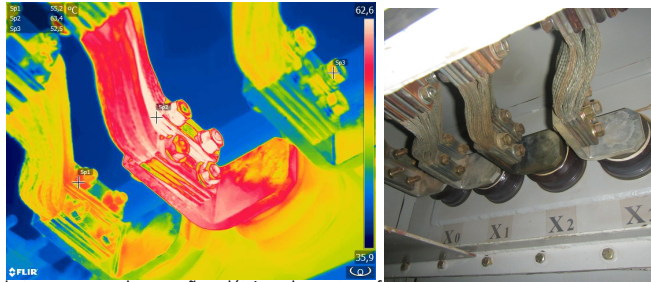
Exemplo de termograma de conexões elétricas de um transformador com mal contato elétrico nas conexões externas (imagens de arquivo da JIT Brasil).

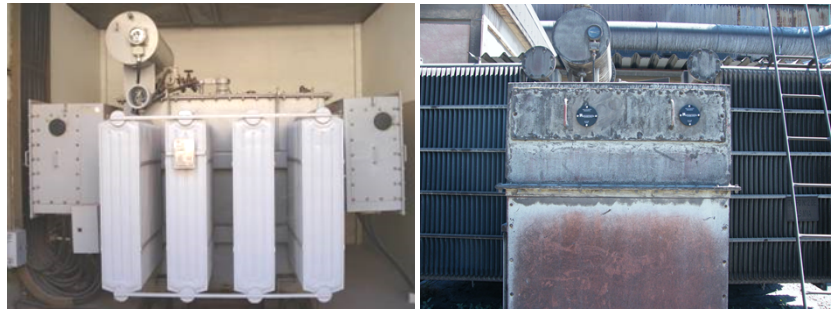
Exemplos de Janelas de segurança para inspeção termográfica instaladas na caixa de ligação dos transformadores (imagens do arquivo da JIT Brasil)

The following figure shows an example of the installation of a thermographic inspection window in an oil transformer, as can be seen, depending on the size of the box, one to three thermographic windows are required for the primary and secondary transformers.

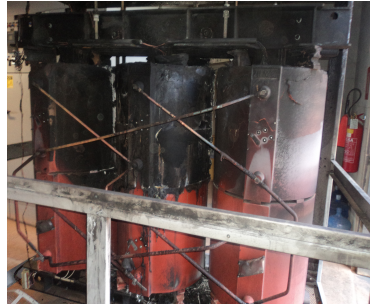
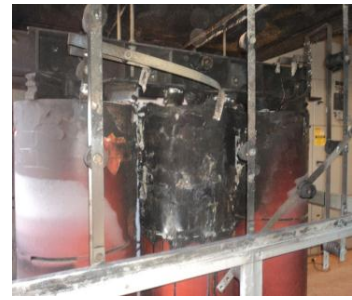
Dry insulation transformers damaged as a result of short circuit – without thermography (Image from JIT Brazil archive).

The photograph in the sequence shows an example of a dry transformer damaged as a result of a fire, where it was not inspected by thermography.

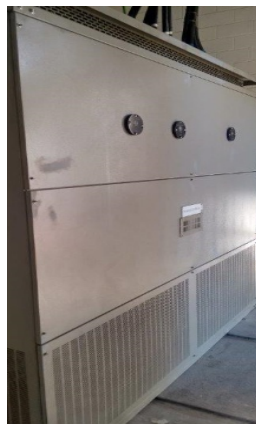
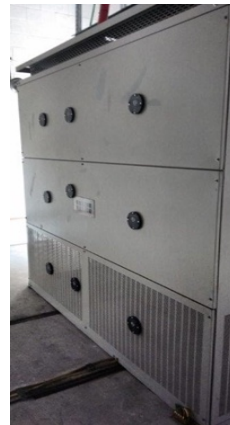
Example of thermographic windows installed in a dry transformer aligned with the internal connections (Images from the JIT Brasil archive).

The photographs below show an example of thermographic inspection windows installed in a dry transformer. In this case, the number of windows will vary, depending on whether the customer wants to inspect the transformer closing connections.

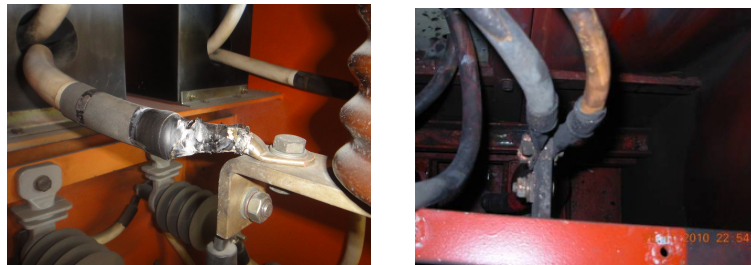
Examples of damaged terminals in motor terminal boxes
(images from the JIT Brasil file).

The example in the photos below shows evidence of damaged terminals and cables in the motor boxes.

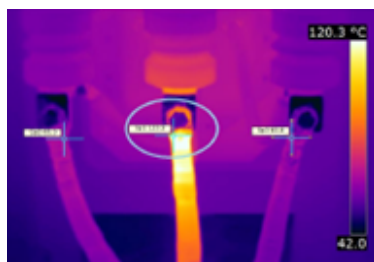
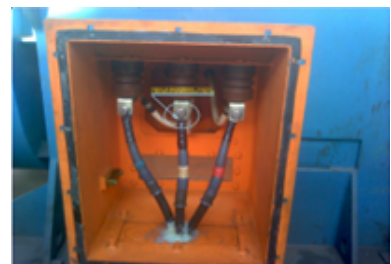
Example of a thermogram with a hot spot in an electric motor connection box, and an open box for repair (images from the JIT Brasil file).

The Figures below show a hot spot on a terminal in the connection box of an electric motor at 120.3°C. The cost of repairing this engine alone would be enough to pay for all the windows to be installed in this operating unit.

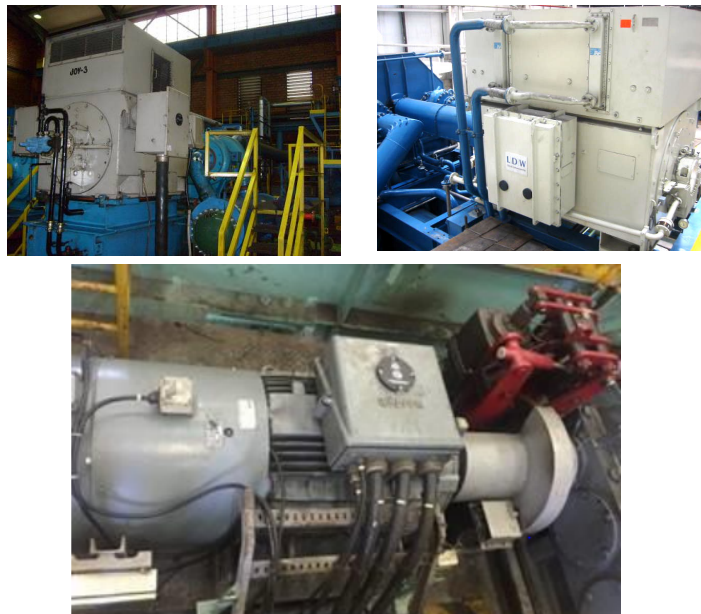
Examples of thermographic window installation in electric motors (images from the JIT Brasil file).

The following photos show some examples of engines with installed windows.

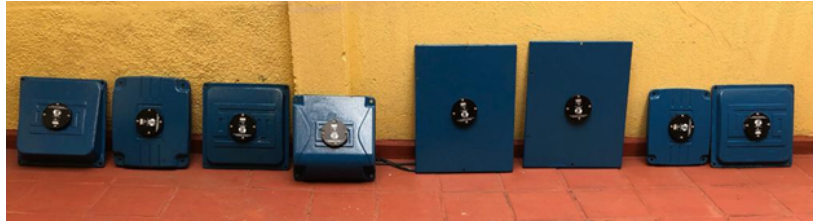
Examples of installation on terminal box covers for motors of various powers. (Image from JIT Brasil file)

To install on motor connection box covers, care must be taken to prepare the surface of the cover, mainly removing embossed marks.

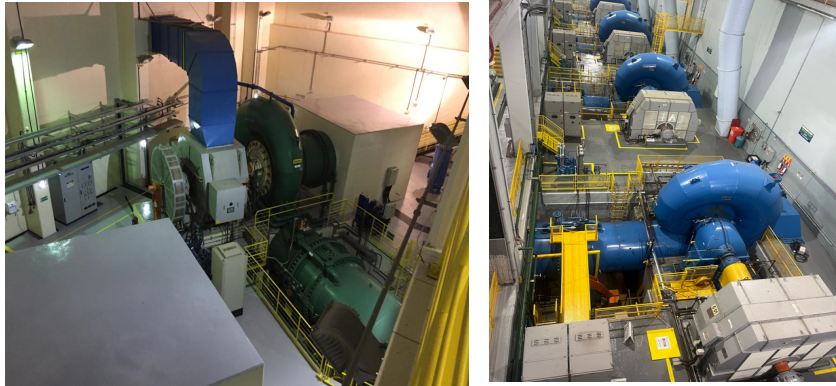
Example of PCH generators with windows installed in the generator connection boxes (Image from JIT Brasil file).

Generating companies are increasingly adopting thermographic windows in the barrel region of generators and other associated assets up to the generator output transformer. Also in the case of PCHs, the number of companies that began to see the need for inspection of this equipment to reduce the fixed staff in the maintenance and operation of these assets is increasing.

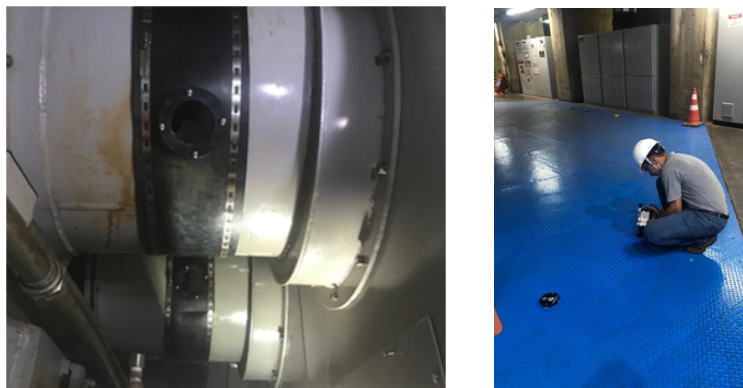
Example of installed windows for internal inspection of Barrel generator and pipeline connections (Image from JIT Brasil file).
